A NEW APPROACH TO OVERCOME OF BOILER FEED WATER PUMP SEIZURES

MANTOSH BHATTACHARYA

ABSTRACT

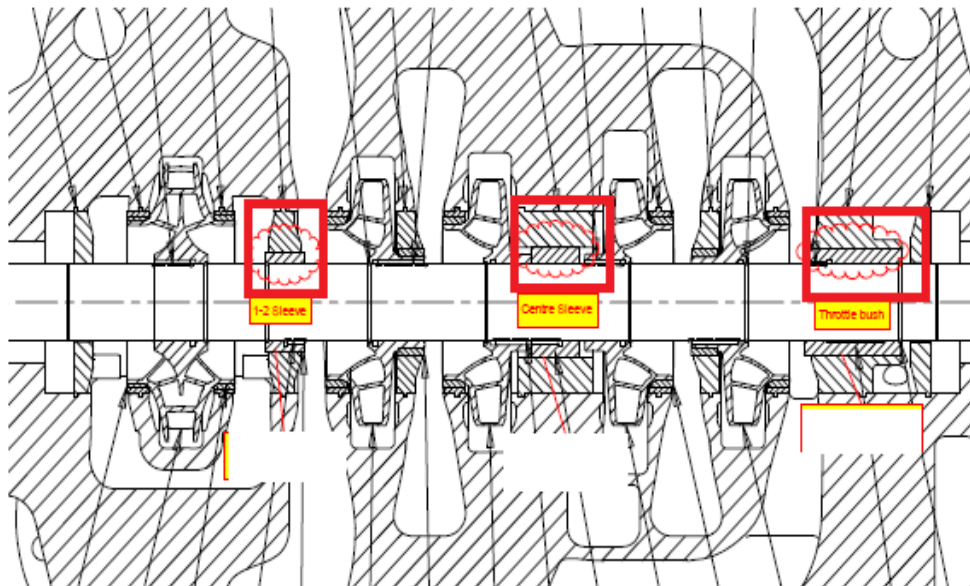
Figure 1: Axially Split Casing -Boiler Feed Water Pump Affected Parts

Two consecutive seizures of motor driven axial split BFW was attributed to ingress of sand which caused scorings on the Throttle bush, center Bush and stage bush. (Refer Figure 1). These failures were caused by huge sand loading in close clearance areas in spite of properly sized strainers installed in respective pump suction lines. These failures can be put in category of pre commissioning teething trouble in loop.

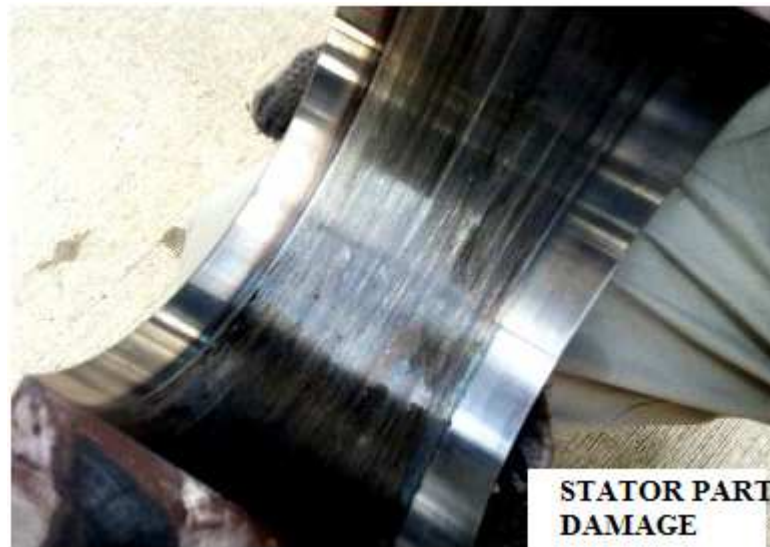
Figure 2: Stator Part Damage Due to Seizure

- There are no indications of a bearing problem at the DE and NDE.
- No indication of damage to the impellers
- No signs of a problem on the impellor case and hub wear rings

Extent of damage is shown in below pictures 2, 3, 4 –

First suggestion was jointly proposed for increasing clearances between close parts as much possible on items in side API 610 limit as long till it does not increase the vibration and observed decrease in volumetric efficiency of pump.

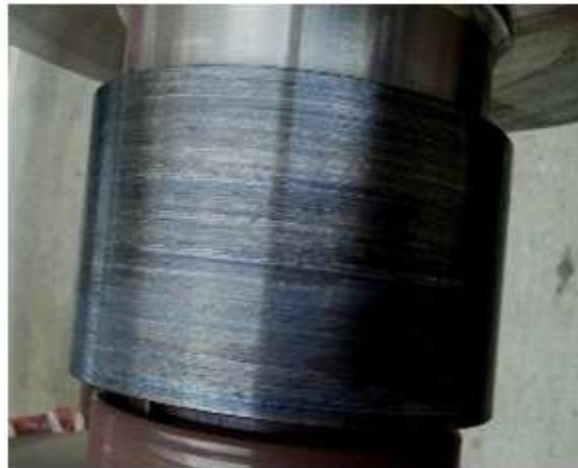
Figure 3: Repeated Attempts to Start Further Aggravated the Issue Taking Out the Metal from Bush

- **Foreign Object Caused Damage:** No foreign object found inside casing, the deep groove mark is due to metal – metal rub at second attempt of re start.

- **Lack of Lubrication at Close Clearance Parts Leading To Encroachment of Clearance Parts during First Start up:** It was observed that – 1. Flow dropped before pump went up its operating speed. When Pump was its operating speed for 5secs, flow was already low. Later on the low flow alarm triggered. by that time close clearance area already lost its lubrication regime and pump seizure occurred.

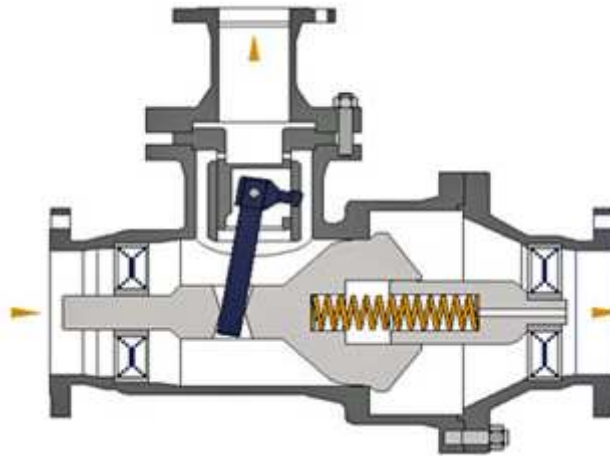
Figure 5: Typical Automatic Re-Circulation (ARC) Valve Commonly Used

In most of the BFW pump installation, instead of control valve - Mechanical ARC (Automatic Re-Circulation Valve- refer figure 1) is preferred due to following reasons. It is 100% mechanical valve which will ensure pump running above minimum flow without taking instruments feed backs like pressure or flow from main line. In pump loop, sometimes ARC valve are not recommended by pump supplier based on their long experience on similar service .Installing ARC at later stage is implausible as a lots of changes in system are required. This is the part of the problem statement which is described below – The problem statement provides the case and sequential analysis which should be carried in case of such failures occur in BFW pump.

ARC Valve as not suggested by Vendor .Installing ARC at such stage was implausible as a lots of changes in system were required.
