## GEOTECHNICAL ASPECTS OF A GULLY SITE AT OFEKATA II AUTONOMOUS COMMUNITY, AWO-OMAMMA, IMO STATE, SOUTHEASTERN NIGERIA

Jeffrey Chiwuikem Chiaka<sup>1</sup>, Obinna Chigoziem Akakuru<sup>2</sup>, Ozioma Udochukwu  
Akakuru<sup>3</sup> & Bernard E. Benedict Akudinobi<sup>4</sup>

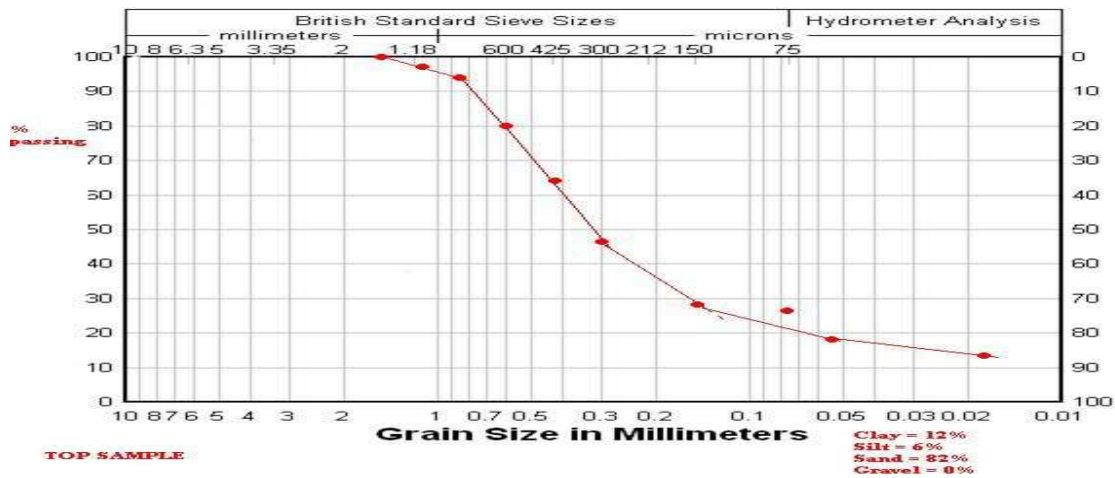
**Figure 4: Sieve Analysis from Top Sample**

The results of sieve analysis presented in Fig. 3, 4, and 5 for the top, middle and bottom soil samples, respectively, show that the grain size distribution is predominantly sandy with a little amount of fines.

Sieve Size (mm)	Mass Retained (g)	Mass Passing (g)	% Passing
2.00	0.0	60.0	100.0
1.18	0.8	59.2	98.7
0.85	4.0	55.2	92.0
0.600	7.1	48.1	80.2
0.425	7.5	40.6	67.7
0.300	12.7	27.9	46.5
0.150	10.7	17.2	28.7
0.075	1.9	15.3	25.5
Pan	0.1	15.2	-
